# Life Prediction and Aging Management of Concrete Structures

## A STATISTICAL APPROACH FOR MANAGING VISUAL INSPECTION AND IN SITU TESTING IN DESIGNING REHABILITATION PROJECT OF A 5 KM LONG VIADUCT

A 120 spans five km long viaduct on the A19 highway Catania -Palermo in Sicily (Italy) was considered for a rehabilitation project by the Italian National Road Administration. In consideration of the great extension of the viaduct and in order to optimise the rehabilitation cost a detailed visual survey and in situ inspection campaign was carried out. Potential mapping, carbonation and chloride profile determinations on concrete cores and concrete compression strength determination on concrete cores were extensively used as diagnostic techniques. The great amount of obtained data allowed a statistical evaluation of structural members degradation. Potential mapping was extensively used to evaluate corrosion of prestressing steel in beams. Four different potential values distributions were obtained for the following beam areas: heads of the left and right edge beams, heads of the internal beams and central zone of the beams. In spite of the good concrete quality, a mean carbonation depth

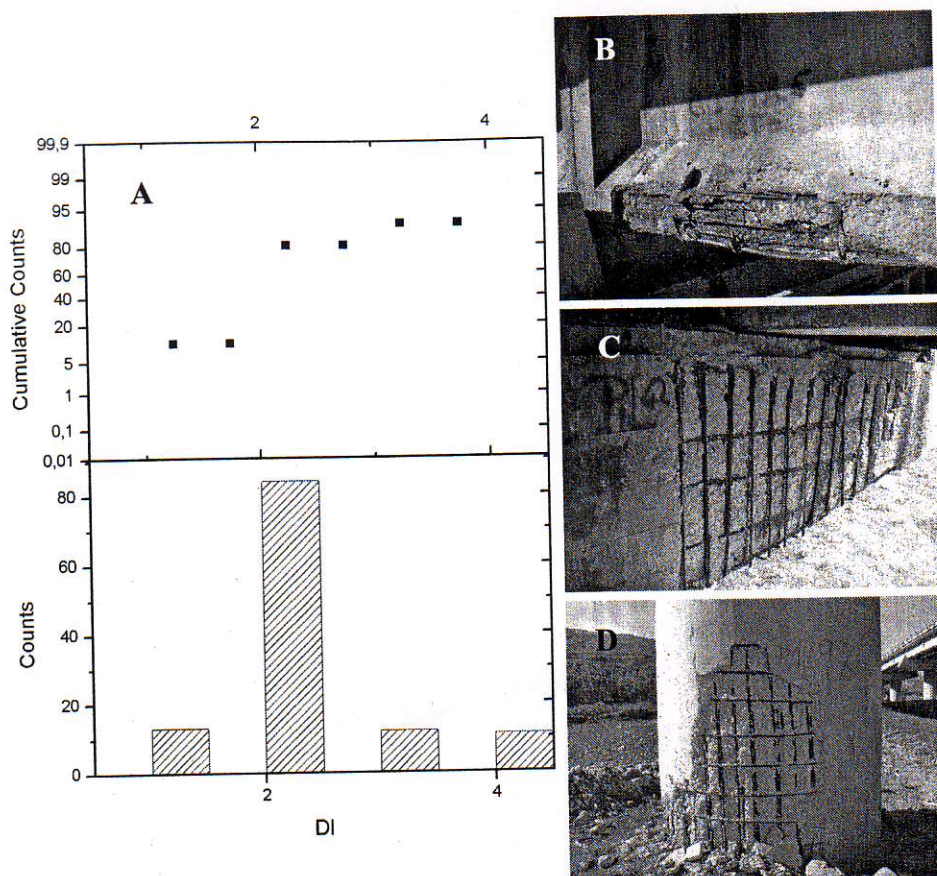
Three main structural members were identified for the in situ visual inspection: piers, pier caps and beams. Damage on structural members were identified by means of a four level Damage Index (DI) calculated taking into account type (cracks, rust spot, rebar corrosion, etc..) and extension of defects, their influence on member safety, and urgency of intervention. A DI of the span was then calculated as a weighted sum of structural members DIs [1]. From a statistical analyses of the visual inspection data it resulted that about 19% of the spans were classified with a DI higher than 3 (Figure 2).

Figure 2: A) Frequency and cumulative frequency plot for DI calculated for the 120 spans. B) Example of DI 4 for a beam. C) Example of DI 4 for a pier cap. D) Example of DI 4 for a pier.

On beams the damages were concentrated at lower flanges of the beam ends as a consequence of poor detailing and inadequate drainage system (Figure 2B). A similar problem was found on some pier caps where expansion joints resulted damaged or an inadequate deck waterproofing was present (Figure 2C). As far as pier degradation is concerning it was found that degradation originated from a different cause. The great part of the damages were in fact concentrated at the pier bases (Figure 2D) as a consequence of polluted water suction from ground water table. On the basis of the visual inspection it was planned an in situ testing campaign optimised to the evaluation of concrete degradation and to the evaluation of the beam strand corrosion status. Potential mapping, carbonation and chloride profile determinations on concrete cores and concrete compression strength determination on concrete cores were extensively used as diagnostic techniques. Since the great extension of the viaduct in order to limit inspection costs it was decided to limit the testing to specific area section of the structure considered to be more critical or more representative of the degradation status (DI 2 to 4).

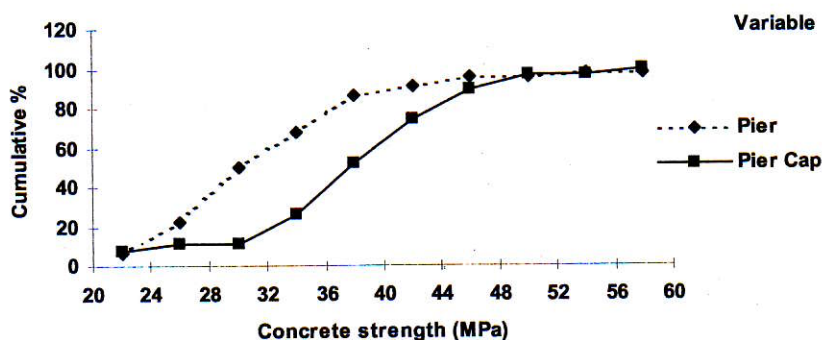
Concrete strength was evaluated on concrete cores (100 mm nominal diameter) following BS 1881[2] and calculated as estimated in-situ cube strength ( $f_{cu}$ ). From a statistical analyses it resulted that concrete strength values for piers and pier caps belong to two different distributions as it is shown in Figure 3. Mean calculated value for pier was 32.40 MPa, whilst for pier caps it was 39.45 MPa. If we consider as a reference a value of 30 MPa it is possible to note that for piers about 52% of the determinations resulted lower than it, while for pier caps such percentage it reduces to about 12%.

Figure 3: Cumulative percentage frequency for concrete strength values of piers and pier caps evaluated on cores

It should be evidenced however that above mentioned distribution were influenced by the presence of strongly deteriorated structural members. It was observed in fact the minimum values of concrete strength were related to the higher levels of concrete contamination by chloride and/or sulphate or to the higher levels of carbonation.

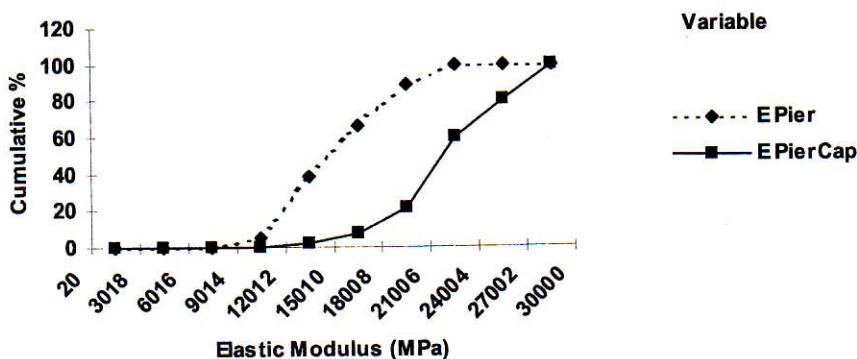
A similar result was obtained for elastic modulus (E) values, where two different distribution were observed. E mean value for pier was 16,962 MPa whilst for pier caps E mean value was 23,743 MPa, that is about 84% and 19% of measured values were below 20,000 MPa for piers and for pier caps respectively (Figure 4).

Figure 4: Cumulative percentage frequency for elastic modulus of concrete: piers and pier cap

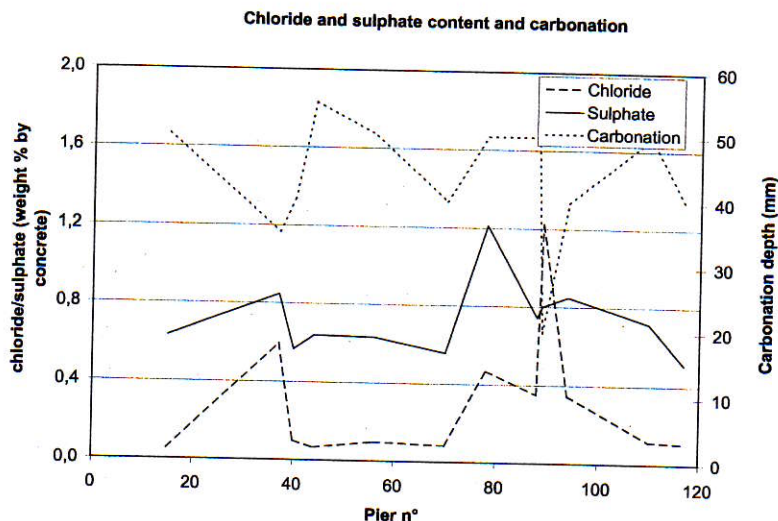
Total chloride and sulphate concentration profile was evaluated in concrete cored at a height of 0.5 m from ground. On piers their content varied along the route of the viaduct (Figure 5). More precisely high contaminant content was observed for those piers that founded directly on the river bed. Chloride content values were frequently higher than 0.5 % (weight by concrete) at a depth of 1.5 cm. In some case such values were maintained up to a depth of 5 cm. Also sulphate content was particular high in critical piers with values ranging between 1 and 1.8 % (weight by concrete). In those case frequently an inversion between the internal (3-5 cm depth) and the external (0-1.5 cm depth) values occurred as a consequence of pollution originating from ground water capillary suction instead than from water percolation on external surface. That was confirmed by the lower contaminant content observed on concrete cored at a height of 2 m.

Carbonation depth, evaluated by means of phenolphthalein test, ranged from 40 and 50 mm with minor values obtained in piers with the higher contaminant content congruently with the consideration that an higher contaminant content corresponds to a higher water content and a lower carbon dioxide diffusivity.

Figure 5: Chloride and sulphate content and carbonation depth on piers (mean values on 3 cm concrete depth)

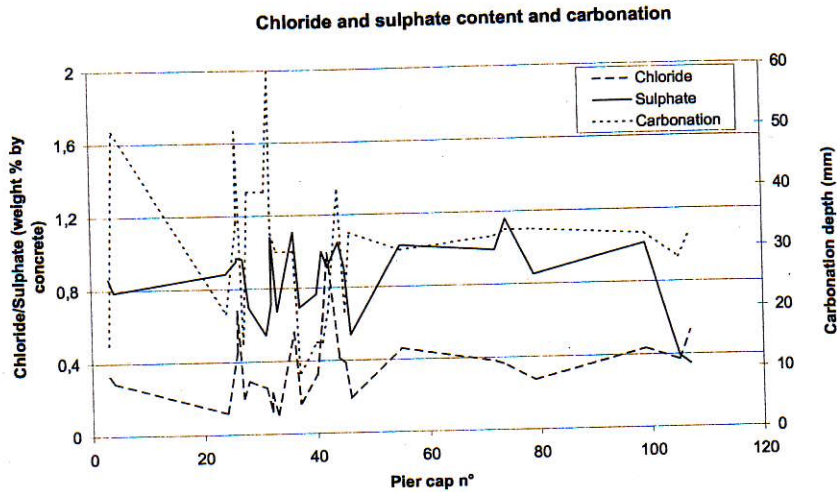
Figure 6: Chloride and sulphate content and carbonation depth on pier caps (mean values on 3 cm concrete depth)

Contaminant level resulted quite high in pier caps (Figure 6), and values remained high also at a depth of 5 cm. On more damaged piers it was observed an inversion of contaminant content on depth (higher level at a depth of 3-5 cm than on the surface). A leaching effect by water percolating from deck was supposed. Mean carbonation depth was about 30 mm, even if in some cases peaks as high as 60 mm were recorded.

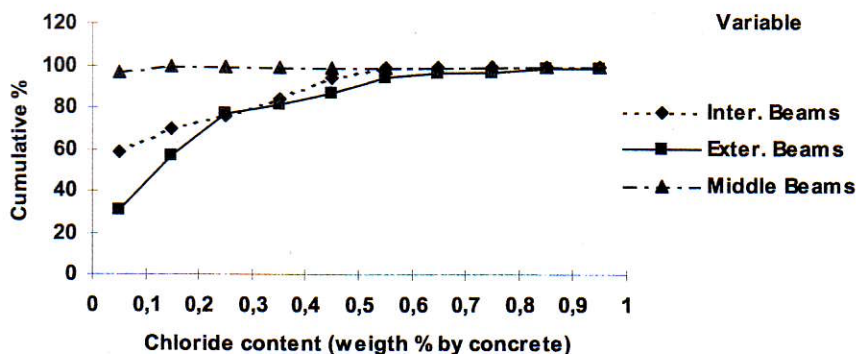
Chloride content was evaluated in concrete cored from lower flange of the beams at a distance of 0.5 m from bearings. In this case three different homogeneous populations were identified, that is concrete samples collected from edge beams (number 1 and number 5 external beams, see Figure 1), concrete samples collected from internal beams (number 2, 3 and 4 beams) and concrete samples collected from the middle of the beams. Since chloride contamination originated from defective expansion joints of the deck and drainage systems (generally located near the bearing), concrete contamination was not in this last case influenced by the beam location in the girder. Three different chloride content distribution were in fact observed (Figure 7): external beams having the higher chloride content compared to internal beams and to beam middles (mean chloride content equal to 0.24, 0.15 and 0.03 weight % by concrete were observed respectively).

Figure 7: Cumulative percentage frequency of chloride content in the beams (means on 3 cm concrete depth)

Considering the good concrete quality (a mean carbonation depth of 16 mm was recorded on concrete cores after 30 years) the extremely high values of chloride content measured on some beams evidenced the critical state of some bridge spans.

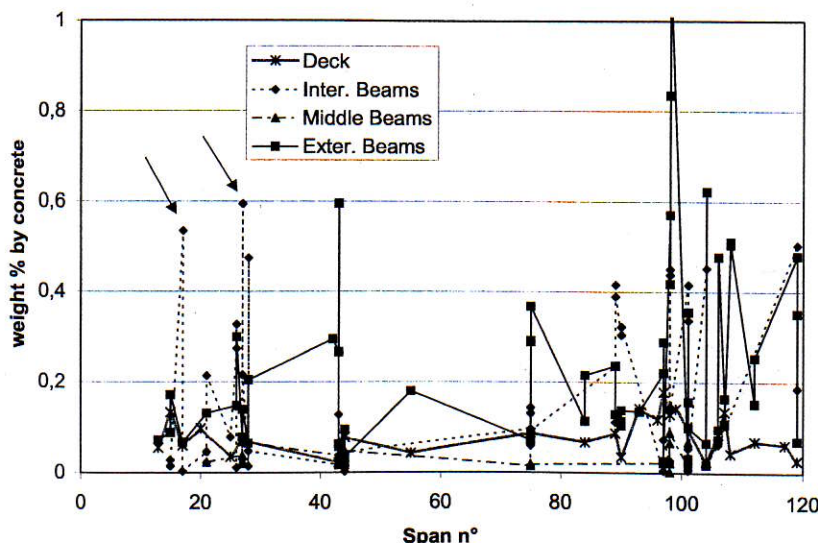
These critical areas of the viaduct can be easily identified by plotting chloride content versus span number as reported in Figure 8. Here contamination level of concrete cored from deck was also reported. The high values reported for internal beams on span 17 and on span 27 (arrows in figure 8) were connected to water percolation from north to south carriageway in first case and, in the second case, to water percolation from north to south carriageway that, at this point cross over the south to north carriageway. High level of pollution observed in external beams of the spans numbers 98 through 106 was supposed to be connected to the curvature of the carriageway which could favour loss of salt from trucks.

Figure 8: Chloride content in concrete (mean on 3 cm concrete depth) cored from beams and deck versus span number.

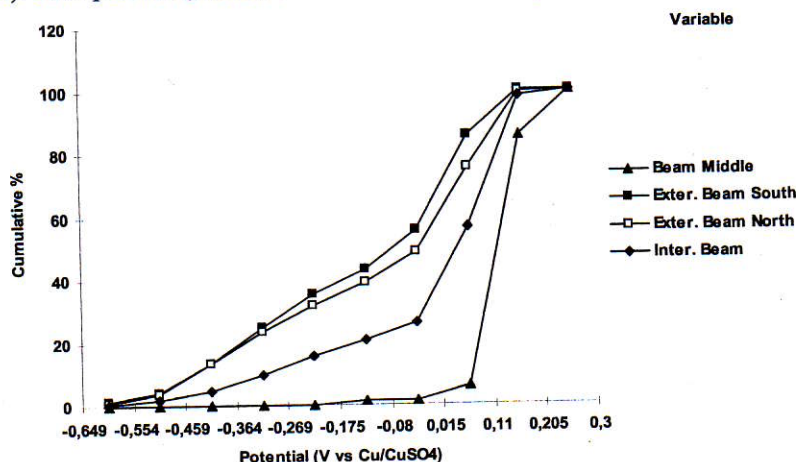
Potential mapping was performed only on limited areas of the beams (1.6 x 3 m with 90 reading points) located at the lower beam flange by mean of electrical connection to prestressing steel. According to the same consideration done for concrete core location, inspection areas were placed near the bearings and (as a reference) in the middle of the beams. Four homogeneous areas were therefore identified: north and south exposition external beams, that is beam number 1 and 5 respectively (it was supposed that sun exposition could affect potential values), internal beams and beam middles. Four different distributions of the potential values were recognized as evidenced in Figure 9 where cumulative percentage frequency for each population is reported. Beam middles areas were characterized by very positive values (dry concrete and passive steel) being 99% of the measurements higher than 0 V (vs Cu/CuSO<sub>4</sub> reference electrode). Positive and very negative (lower than -0.350 V) potential values were instead recorded on areas located near bearings. For external beams, south exposition and north exposition, more than 30% of the values were below -0.200 V (34 % and 31.5 % respectively) and almost 16% of the values less than -0.350 V (for both distributions). Such percentage reduces to 14% and 5.5 % respectively for internal beams.

Figure 9: Cumulative percentage frequency of potential mapping values

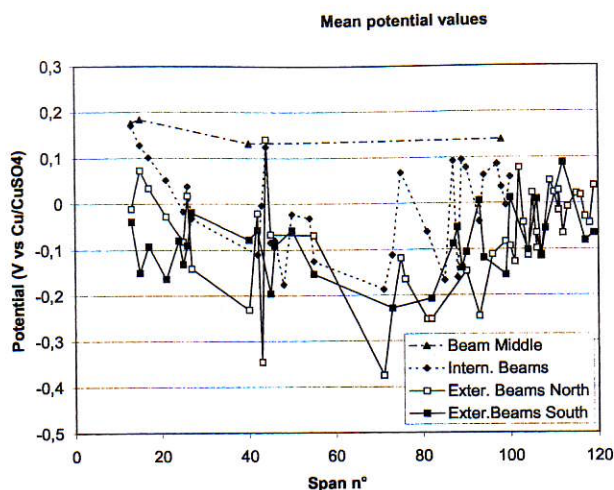
Further information about corrosion status of prestressing steel could be obtained by plotting the mean potential values (mean on 90 readings) of the inspected area along the route of the viaduct (Figure 10). After span n° 27 (cross over point) there is an inversion between "north exposition" external beam and "south exposition" external beam, the last one being initially characterized by lower values. An "U" trend is evident for all readings with a gradual decrease of mean values in the middle of the viaduct route, where it is possible to evidence two "hot spots" (span number 43 and number 71) characterized by mean values less than -0.350 V.

Figure 10: Mean potential values for the different four areas along the viaduct route
