# IABMAS'04

Second International Conference on  
Bridge Maintenance, Safety and Management

# Evaluation of Fire Damage on a Prestressed Concrete Railway Bridge

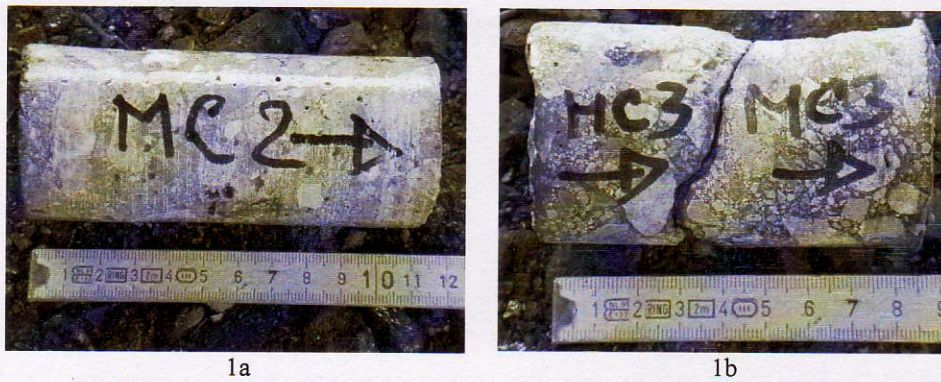
Figure 1. Concrete cored from an undamaged beam (left). Concrete cored from a beam exposed to fire (right)

In order to detect the status of the structure, at a first time, a visual *in loco* examination and, in a second time, a laboratory study, accordingly to an experimental program developed from NIST, were carried out (Phan 2001). The laboratory study was conducted in two phases. In the first phase an evaluation on samples cored from the undamaged area of the structure was carried out, these samples were considered as references (Fig.1a); in a second samples were "artificially" deteriorated in a temperature controlled furnace, in order to stimulate irreversible transformations of concrete constituents at the different temperatures. The second step of the study was performed on samples cored from some areas severely damaged by the fire (Fig.1b). All concrete samples had a cylindrical shape with a 50 mm or 80 mm diameter.

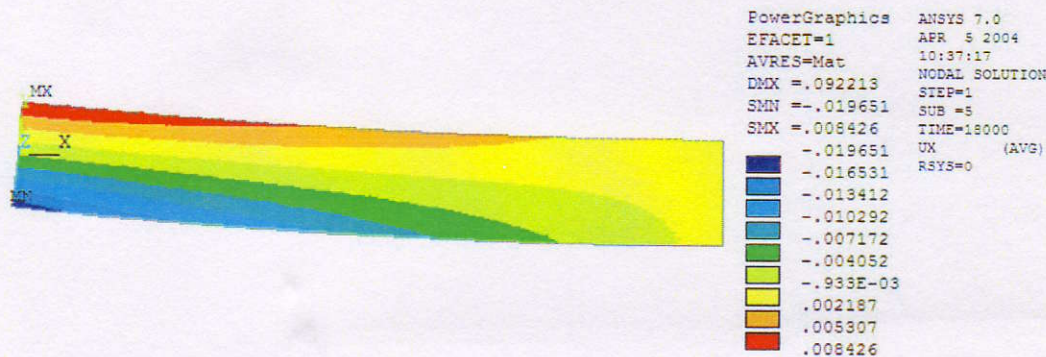
Figure 8. X axis displacement [m] in the concrete beam model after  $18 \cdot 10^3$  s.

With the increasing of the temperature, it was obtained from the numerical analysis that, because to the thermal relaxation (expansion) of the tendons, there was a marked displacement of the beam. Figure 8 shows the deformed shape of the beam and reports the numerical values of the horizontal displacement (x-direction), negative displacement (traction) were observed on the lower side of the model accordingly to cracks location observed on extracted cores (Figure 2 and 3).

The results of the analysis showed that a temperature of 1110 K were reached on the directly exposed surface of the beam, after about 14400 s (4 hours) accordingly to the values estimated by the diffractometric characterization. The maximum temperature reached by the steel tendons (after a time of 18000 s) was about 537 K. Once determined the heating-curve, the evolution of the stress-strain field was studied through a non linear (transient) thermo-mechanical analysis.
