# Life Prediction and Aging Management of Concrete Structures

## A STATISTICAL APPROACH FOR MANAGING VISUAL INSPECTION AND IN SITU TESTING IN DESIGNING REHABILITATION PROJECT OF A 5 KM LONG VIADUCT

A 120 spans five km long viaduct on the A19 highway Catania -Palermo in Sicily (Italy) was considered for a rehabilitation project by the Italian National Road Administration. In consideration of the great extension of the viaduct and in order to optimise the rehabilitation cost a detailed visual survey and in situ inspection campaign was carried out. Potential mapping, carbonation and chloride profile determinations on concrete cores and concrete compression strength determination on concrete cores were extensively used as diagnostic techniques. The great amount of obtained data allowed a statistical evaluation of structural members degradation. Potential mapping was extensively used to evaluate corrosion of prestressing steel in beams. Four different potential values distributions were obtained for the following beam areas: heads of the left and right edge beams, heads of the internal beams and central zone of the beams. In spite of the good concrete quality, a mean carbonation depth

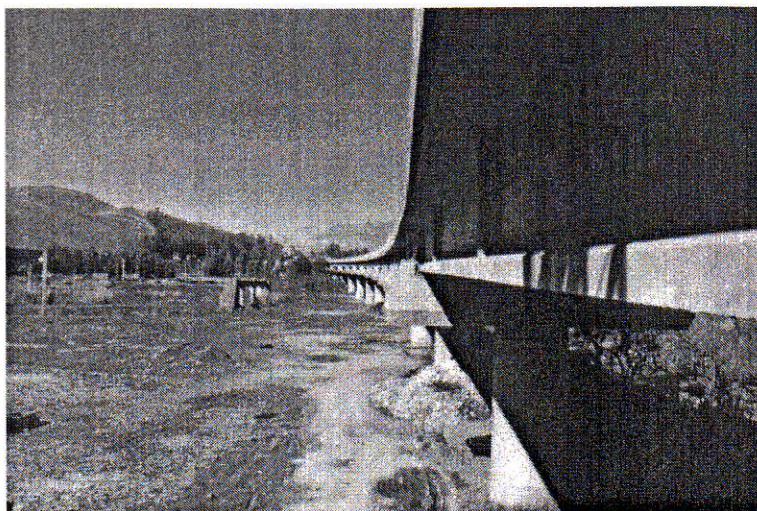
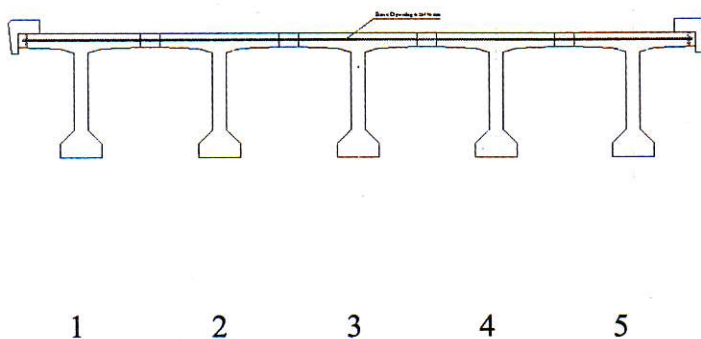
Figure 1: Side view and transversal section scheme of the Cannatello viaduct

Chloride content was evaluated in concrete cored from lower flange of the beams at a distance of 0.5 m from bearings. In this case three different homogeneous populations were identified, that is concrete samples collected from edge beams (number 1 and number 5 external beams, see Figure 1), concrete samples collected from internal beams (number 2, 3 and 4 beams) and concrete samples collected from the middle of the beams. Since chloride contamination originated from defective expansion joints of the deck and drainage systems (generally located near the bearing), concrete contamination was not in this last case influenced by the beam location in the girder. Three different chloride content distribution were in fact observed (Figure 7): external beams having the higher chloride content compared to internal beams and to beam middles (mean chloride content equal to 0.24, 0.15 and 0.03 weight % by concrete were observed respectively).
